Procedia Structural Integrity 1 (2016) 212–217

XV Portuguese Conference on Fracture, PCF 2016, 10-12 February 2016, Paço de Arcos, Portugal

Failure analysis in railway wheels

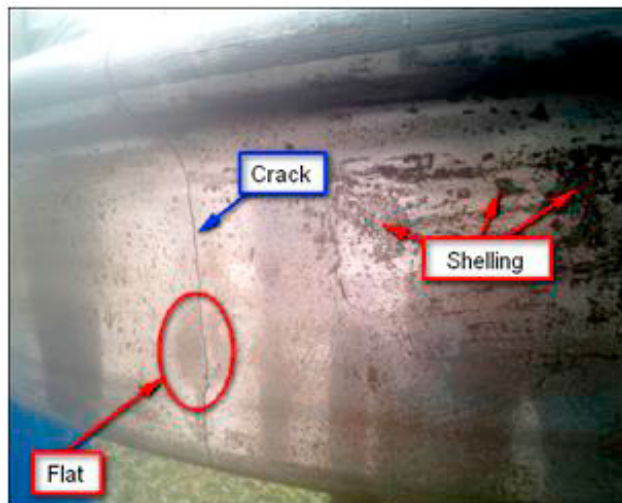
The present paper studies a real failure case in the Brazilian underground system, where cracks on the contact surface were evidenced, as illustrated on Figure 1. The wheel was manufactured according to the AAR M-107 specification (Association of American Railroad) AAR M 107, (2011), with a class material B (0,5% C) by forged processing. The crack was found after 2 years of wheel operation (first life), around 181.000 km. The pressure of wheelset assembly according to the process is 87ton (min: 77ton / max: 110ton).

Figure 1. Defect on contact surface.

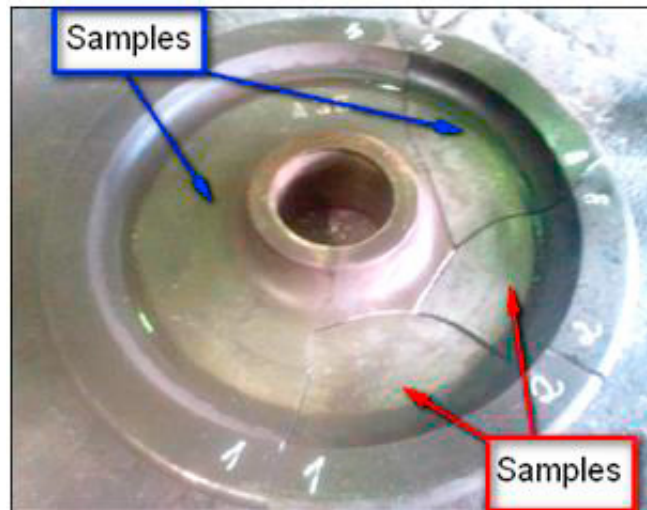
To study the cracks found on the wheel surface, the first step is cutting the wheel without thermal energy input, to avoid metallurgical changes. The falling weight method (1ton - 3m) was applied, and the wheel broke as shown in Figure 2. The original crack was localized in segment 1-2, and this piece is shown in figure 3. The transversal view

Figure 2. Wheel broken.

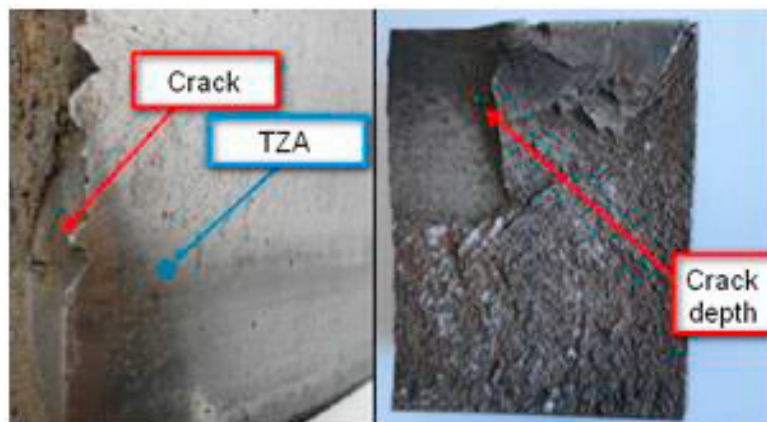
shows the depth of the crack and it is possible see the thermal affected zone (TZA) in the surface contact. The crack depth is around 12 mm and nucleated in the contact surface, on the same region as the thermal mark.

Figure 3. Detail of the surface crack.

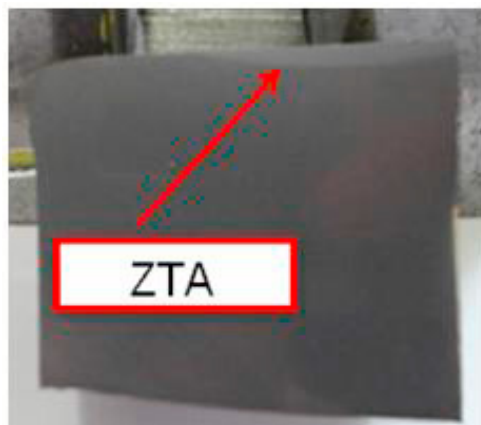
The produced metallurgic analyses aims at evidencing the overheating region on the transversal section of the tread. The chemical attack was made using Nital etching. It is possible see, in Figure 5, the colour change (dark silver and bright silver). The microstructure in the region is changing from austenite to martensite.

Figure 5. Overheated thin layer.

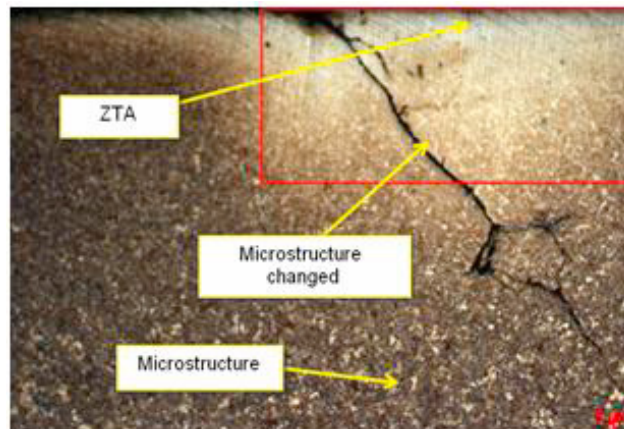
Using optical microscopy, (Figure 6) the microstructure is analyzed and evidence is found that microstructure has changed on the thermal affected zone. In this region, it is possible to visualize martensite and a decarbonized area. The microstructure in the internal region of the wheel is according to the chemical composition (0,5% C) with presence of perlite and ferrite. The crack arises from the ZTA (surface) and grows into the inside wheel.

Figure 6. Thermal affected zone microstructure.

The present work concluded that cracks nucleated from the tread (contact surface between wheel and rail) in the thermal affected zone (ZTA). It was possible to evidence a microstructure change (perlite/ferrite to austenite/martensite), possibly caused by a brake system condition (shoe locking). The crack grew by fatigue process due the cyclic service of the wheel, leading the wheel to fail.
